Presentation to the District of Central Saanich – Hagan-Graham and Tetayut Water Quality Monitoring Programs

April 24th, 2017

Hagan-Graham Summary

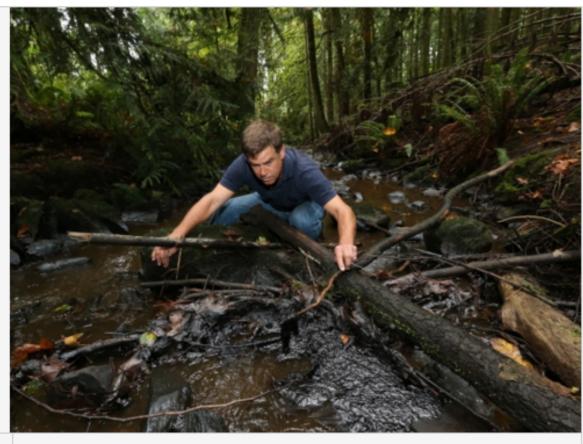
Biologist Ian Bruce examines some of the unknown substance found Friday in Graham Creek, which runs through Centennial Park in Central Saanich. Photograph By ADRIAN LAM, Times Colonist
